T1-333 F

Modelo: STERNMAN

# Revamped Stearman

**Is Safer, More Efficient Duster-Sprayer**

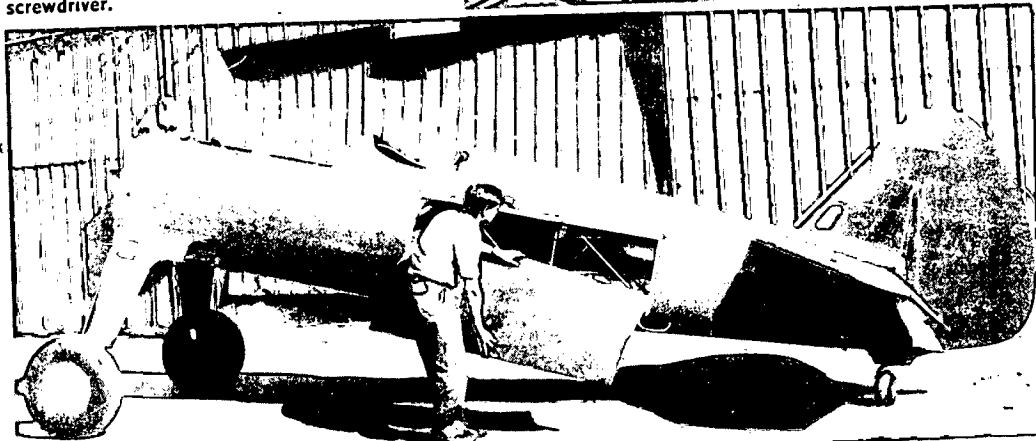
**NA75 FUSELAGE** can be stripped from firewall to tail in five minutes, thanks to quick-detach side panels. These are attached to primary structure with Dzus fasteners—all you need is a screwdriver.

Removable metal fuselage side panels let a mechanic strip the aircraft from firewall to tail in five minutes for the removal of corrosive chemicals from the primary structure.

The ten metal fuselage panels are secured by Airloc fasteners and two men with screwdrivers can strip the aircraft from firewall to tail in five minutes for inspection, easy maintenance, or for the removal of corrosive chemicals from the primary structure.

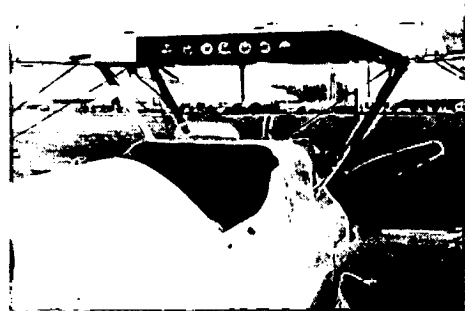
**VISIBILITY** out of NA75 Stearman is good. Instruments are mounted in center wing section in pilot's line of sight in flight.

All instruments are located in the center wing section to keep them in the pilot's line of vision in flight.
